# A Preliminary Survey of the status of the Bourne Stream

Prepared for the meeting on the Farnham group for Wey Valley Catchment Programme 22<sup>th</sup> August 2012

Martin Angel and Noel Moss The Bourne Conservation Group

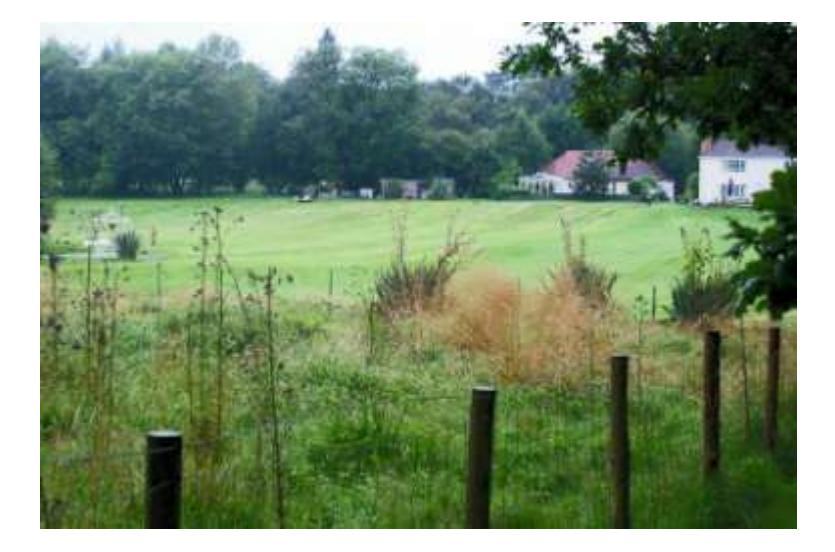
**Figure 5**. Through Rowledge there are stretches of attractive farmland but further downstream there are similar abuses to those found along the urban stretch.

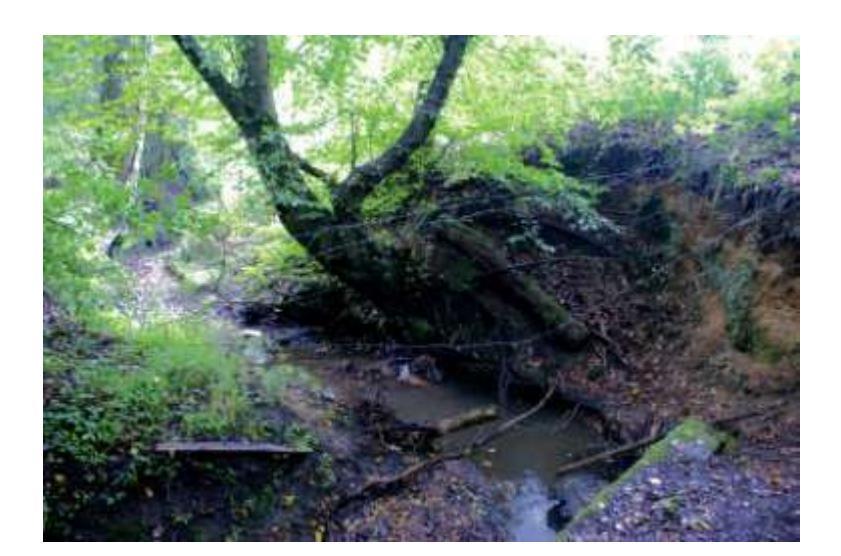
**Figure 6**. Here a potentially small sandy cliff that is attractive and of high biodiversity values is scarred by a jumble of barbed

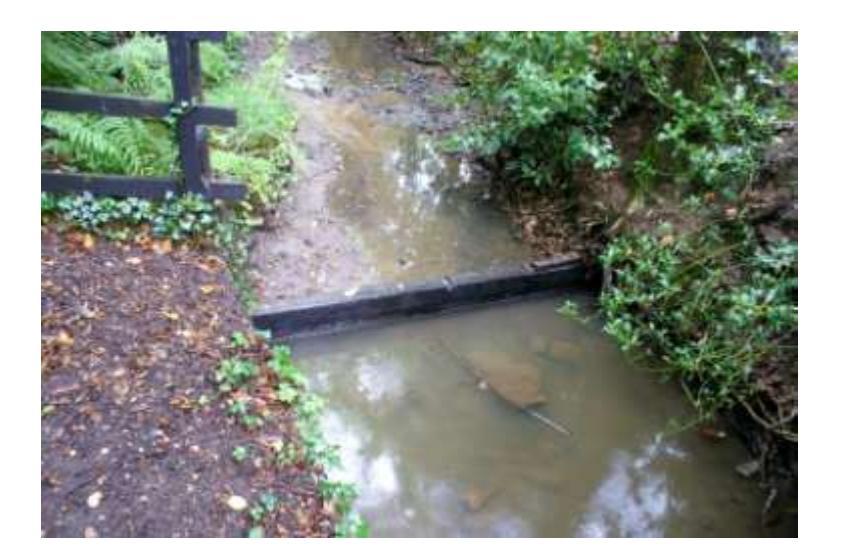
**Figure 7**. Here a private weir is acting as a barrier to the movements of fish and other aquatic animals.

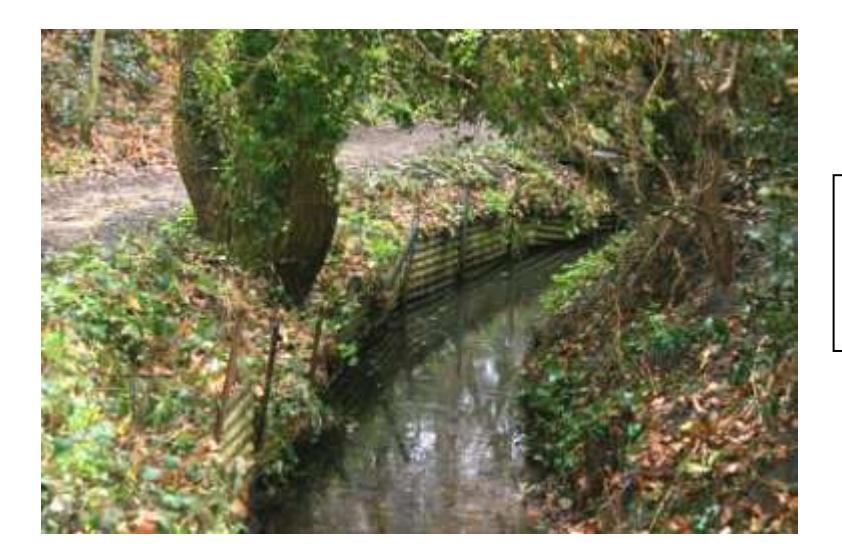
**Figure 10**. An example of some *ad hoc* revetting along the bank of the public footpath near Sandrock Hill.

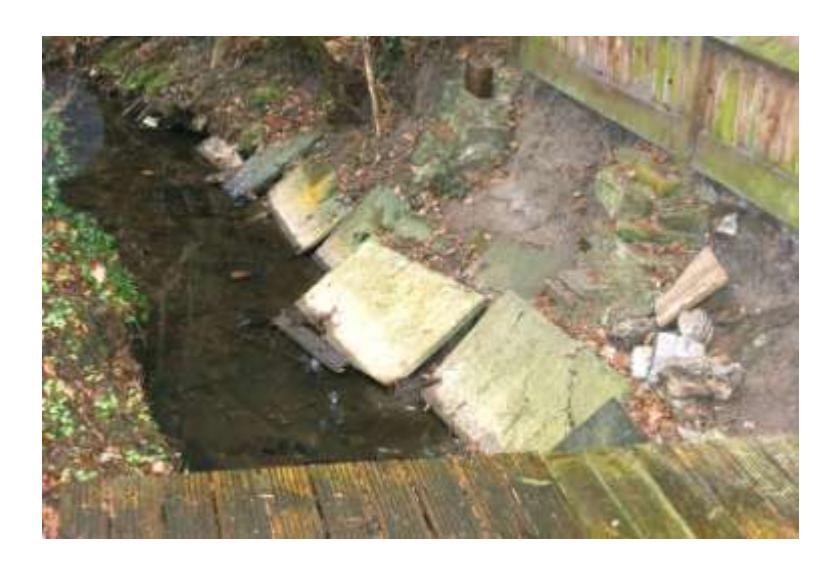
Figure 11. An example of the fate of such an *ad hoc* revetment.

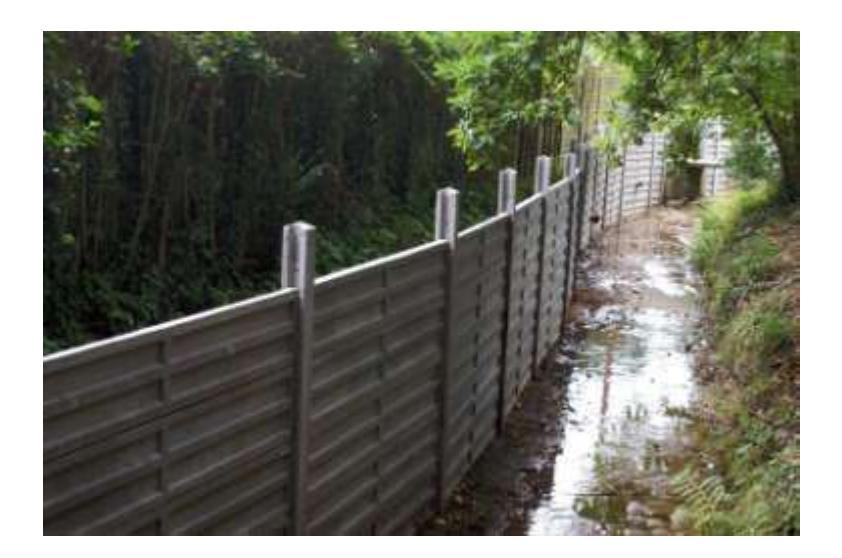
**Figure 12.** Prefabricated revetment recently installed to protect commercial premises - no doubt effective against flooding but very unsightly and not at all wildlife friendly.

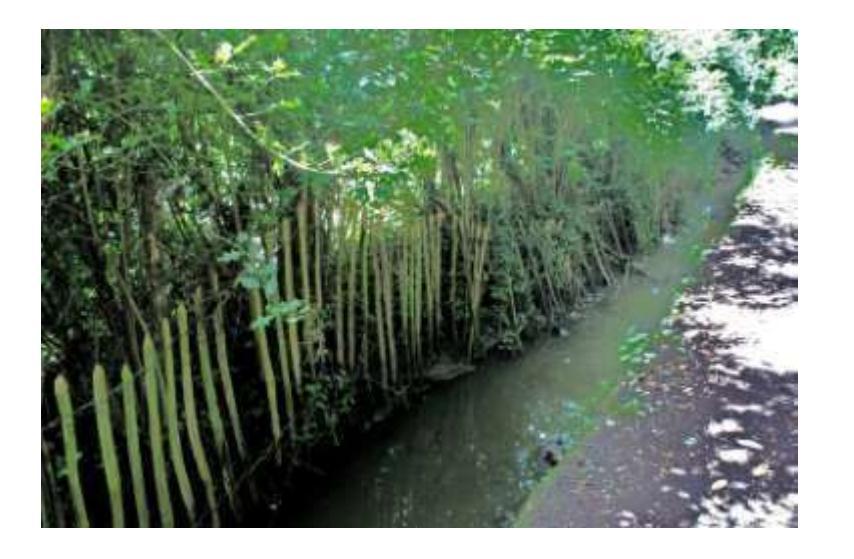
**Figure 13**. Here a boundary fence has become embedded in the stream's bank – not only unsightly but also ineffective.

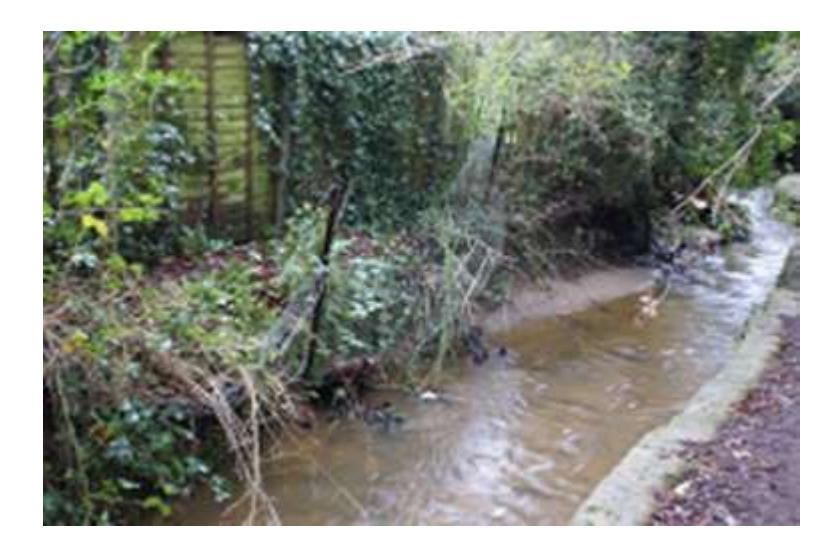
**Figure 14**. An example of a most unattractive house boundary backing on to the stream, with a tangle of posts, netting and fence panels, which is unsightly and inimical to wildlife.

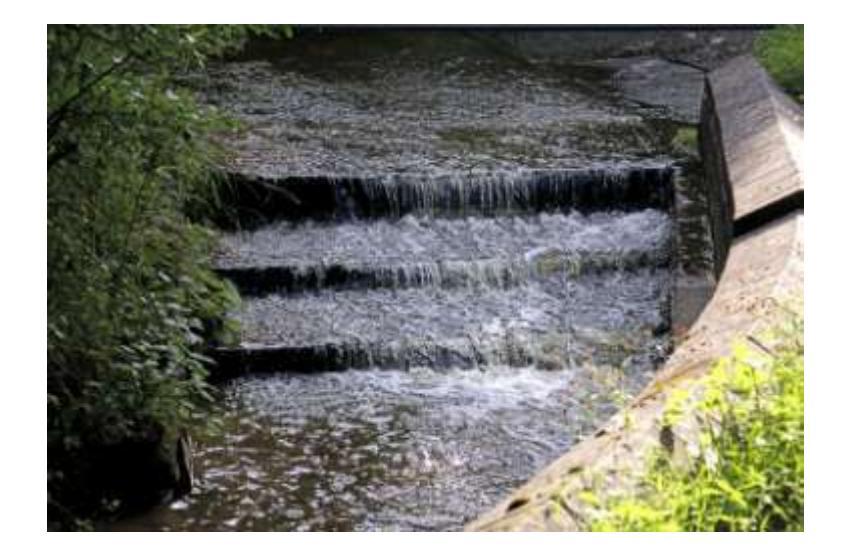
**Figure 15**. The crossing at the bottom of Ford Lane, where runoff from the roads can flow directly into the stream.

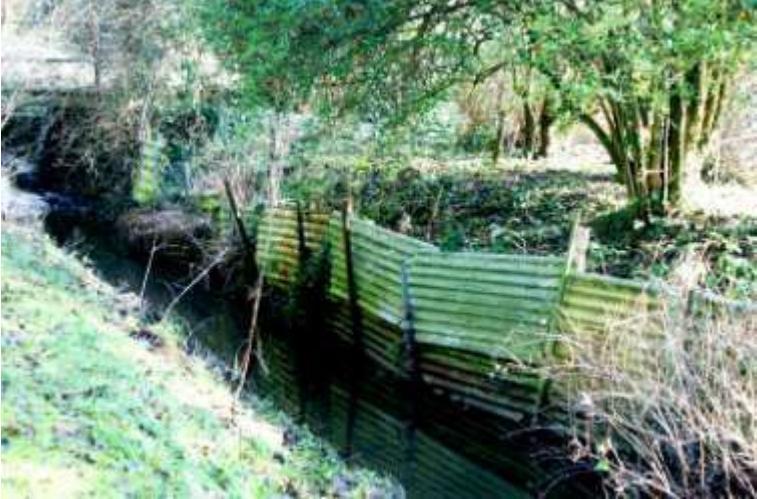
Figure 18. Regrettably the attractiveness of Sturt Walk is marred by this attempt to provide protection from flooding for the property of an OAP. Surely there must be a better way!

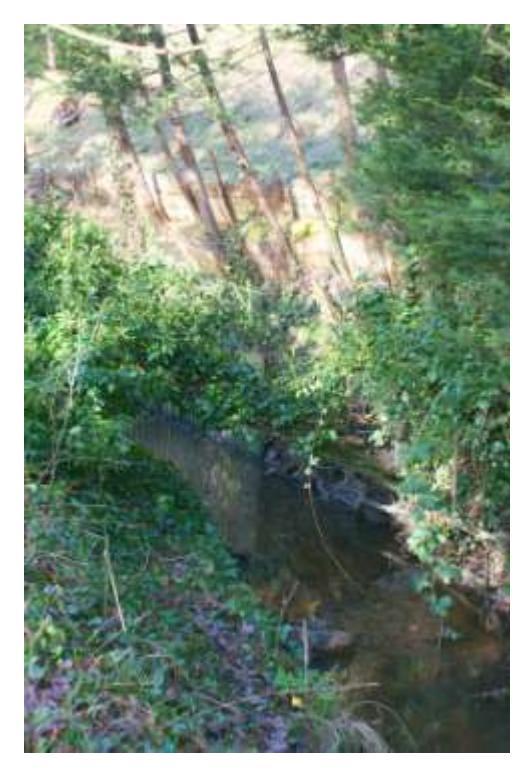
Figure 19. An example of bad engineering. Collapse of this steep bank close to the bottom of Old Church Lane has resulted in local flooding in the past. If properly engineered this embankment could be made not only safer but also more wildlife friendly.

Figure 20. This is a more visually attractive type of revetment put in place by Waverley Borough Council in 2008. So far it has been effective in flood control, but it is not wildlife friendly and what happens when the wood rots?

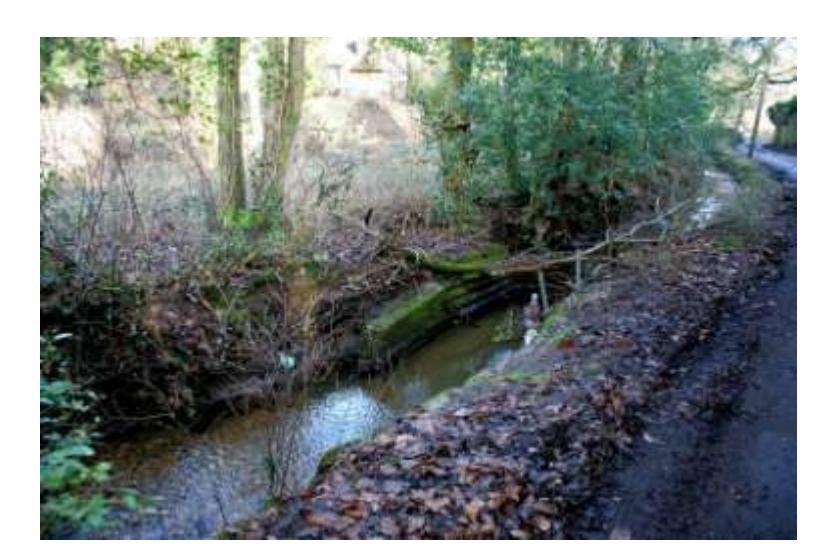
Figure 23. Alongside Bourne Grove, public highway, the stream's embankments tend to be unstable. This stretch is currently the subject of a dispute over ownership of the bank.

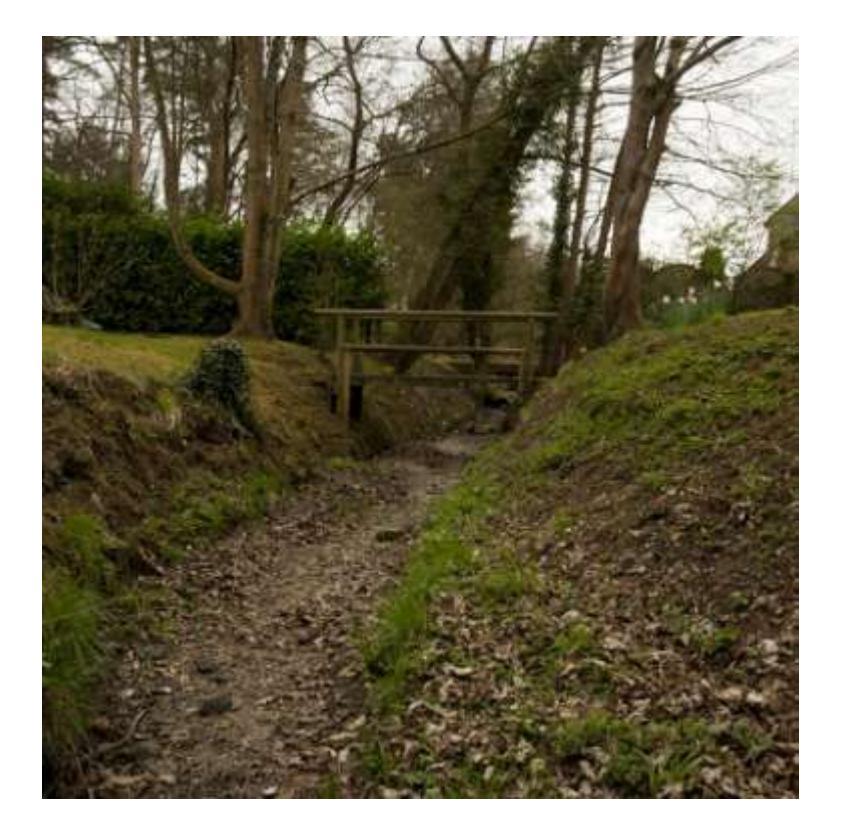
**Figure 25**. The stream just above the bridge carrying the Farnham to Tilford road is the site of an old council depot. It may have been the source of the Japanese knotweed infestations which have occurred around the houses here and is spreading downstream. In March when this part of the survey was carries out the stream was not flowing.

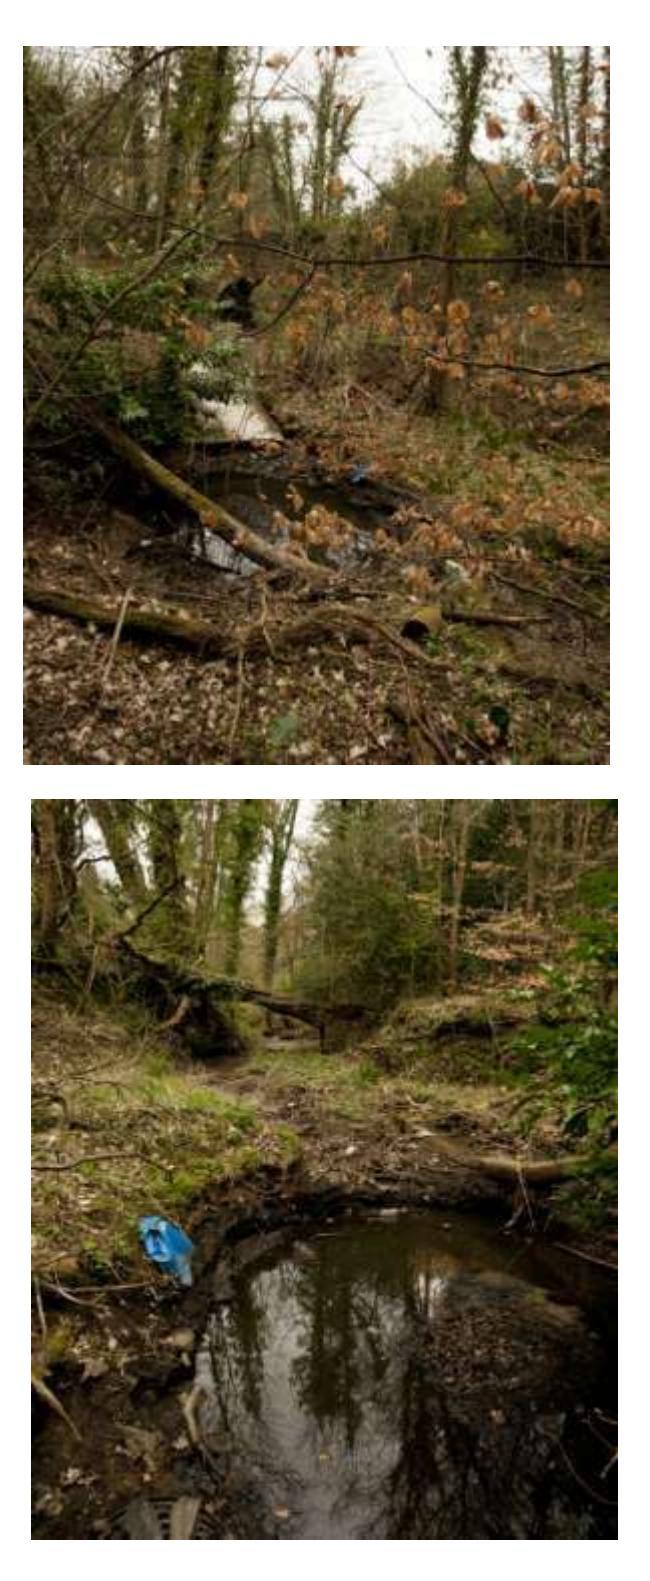
**Figure 26**. Below the bridge is a typical accumulation of brash which has caught up debris that has either been carried downstream of has been thrown or blown over the parapet of the bridge. The sight of rubbish will often encourage others to throw their rubbish into the stream rather than take it home.

**Figure 27**. Under the bridge is a concrete spillway, below which a deep pool has been eroded. Note the plastic rubbish and the first of the fallen trees to be encountered along this stretch.

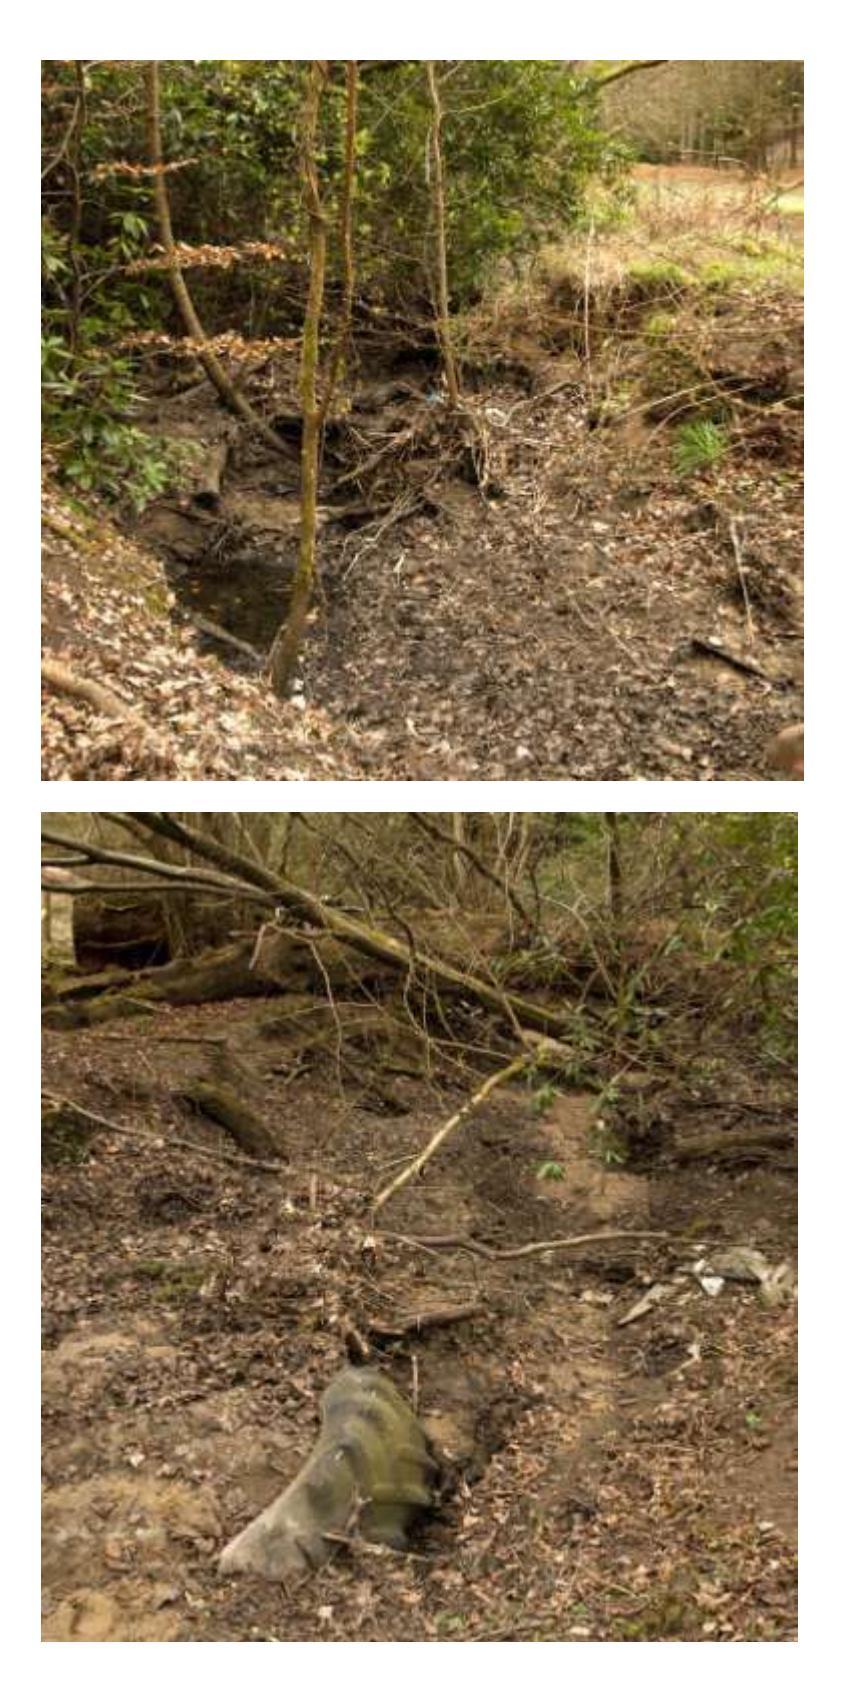
Figure 31. The stream alongside the chicken run is cluttered with brash which has caught artefacts being washed down. There is evidence of bank erosion. Volunteers would be able to clean up these sorts of problems

Figure 32. The stream bed is littered with logs, brash and artefacts and a large tractor tyre lies buried in the substrate. The tyre needs to be dug out and disposed of. This clearance can be achieved using volunteers, but disposal will need the use of a skip.

**Figure 33**. One of several large trees that has fallen across the streambed. At present it is not causing a blockage, but needs to be cleared using a chain saw. The smaller branches are within the capability of a volunteer work force.

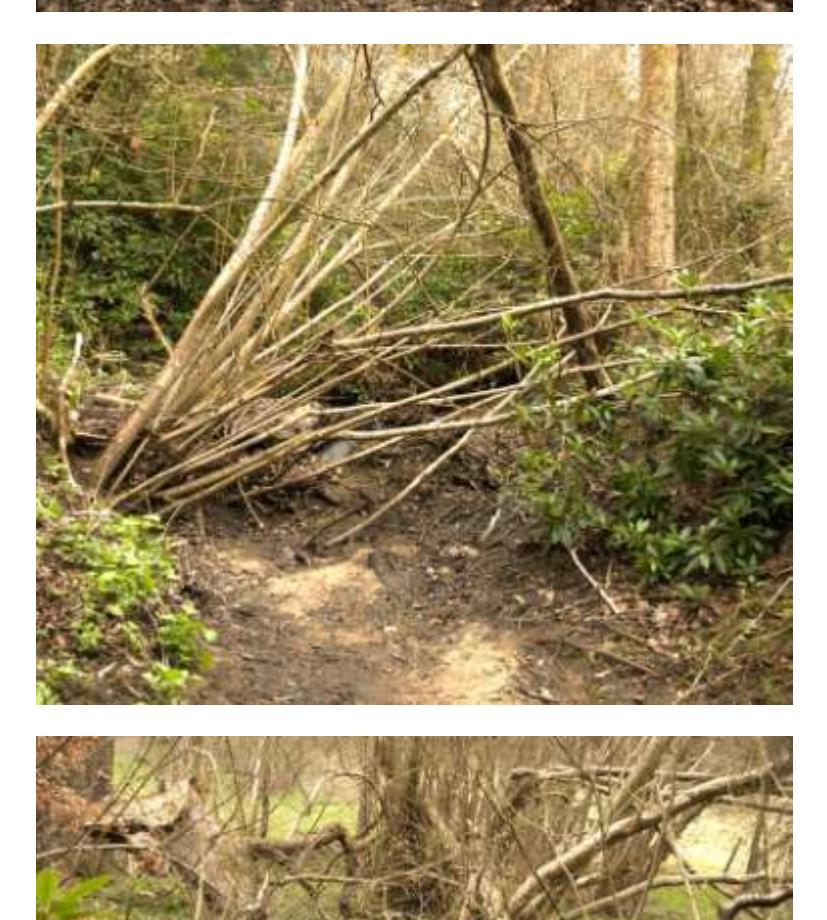
**Figure 34**. Bank erosion has resulted in a coppiced hazel falling into the stream. This will be likely to cause a blockage in the future. The encroaching rhododendron also needs to be cleared.

Figure 35. A more serious blockage caused by a fallen tree, which will need to be cleared using a chain saw.

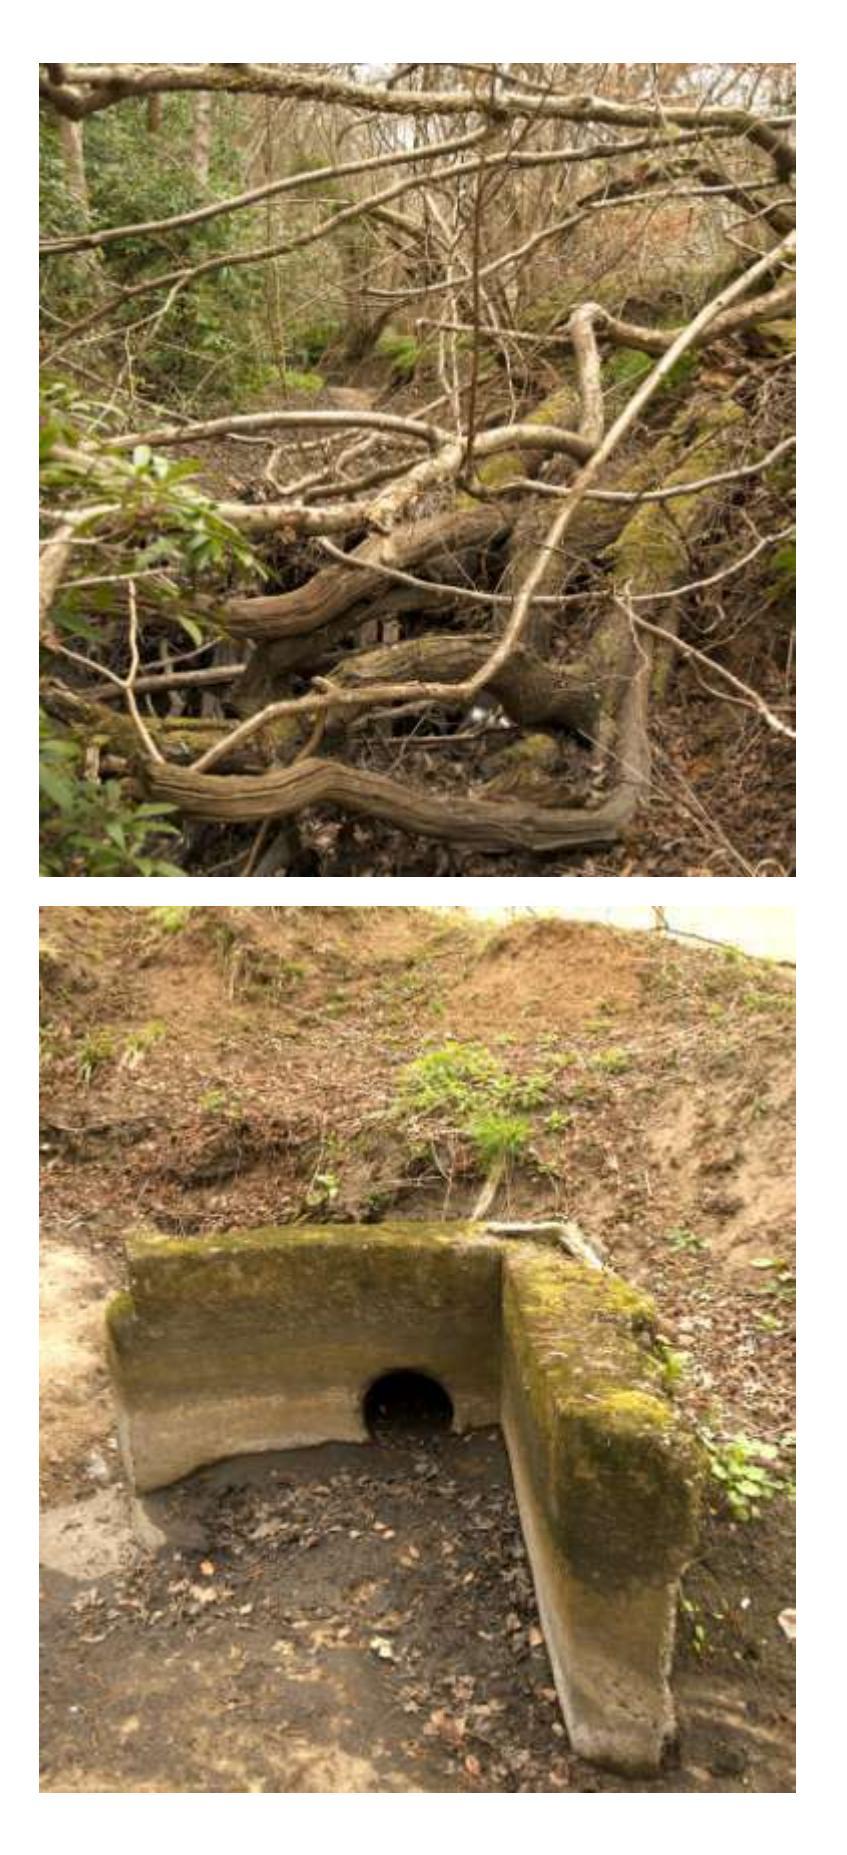
Figure.36. The same blockage as illustrated in figure 32, showing how it has trapped artefacts and brash.

**Figure 37**. A land drain enters the stream near the field boundary between Compton Field and the Redhill House meadow. It is not known when this drain was put in, but there has been extensive bank erosion since then, There is an inspection cover in the dip of Compton Field associated with this drain.

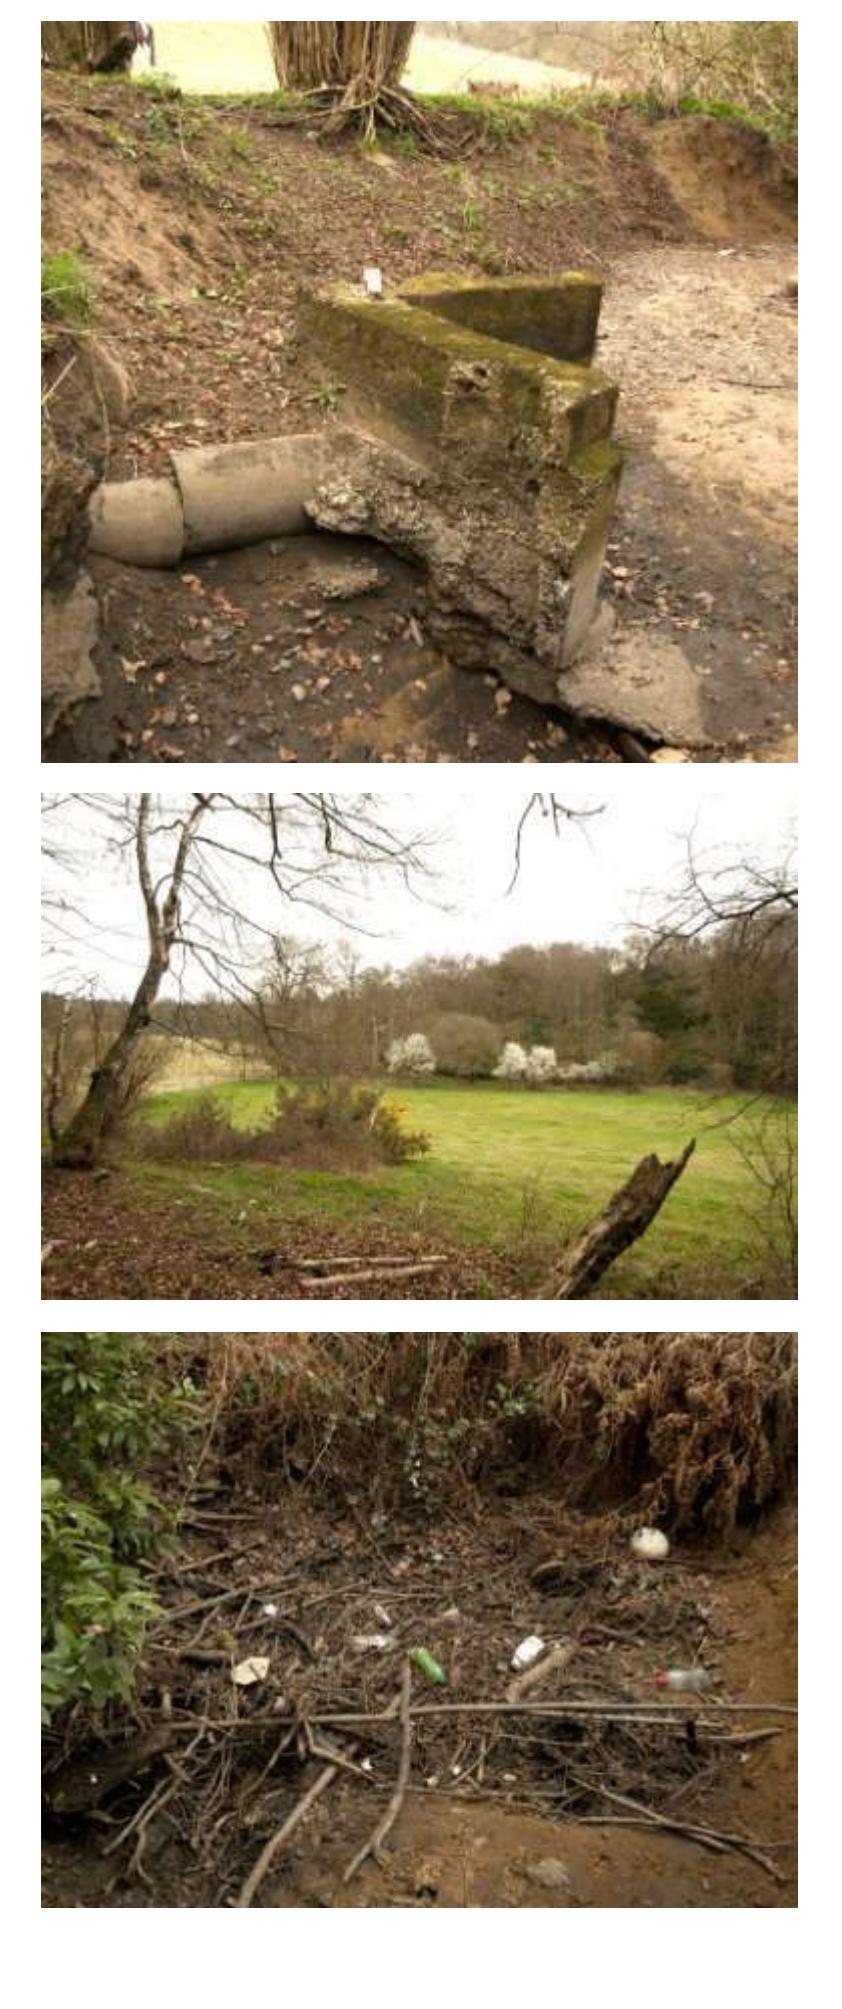
Figure 38. Another view of the land drain outfall showing just how extensive the bank erosion has been. Since this survey was undertaken in March 2012. The stream bed at the outfall has be constantly full of water.

**Figure 40**. Just downstream of the outfall is a blockage caused mainly by overhanging rhododendron – as well as general brash large number of artefacts have accumulated at the blockage

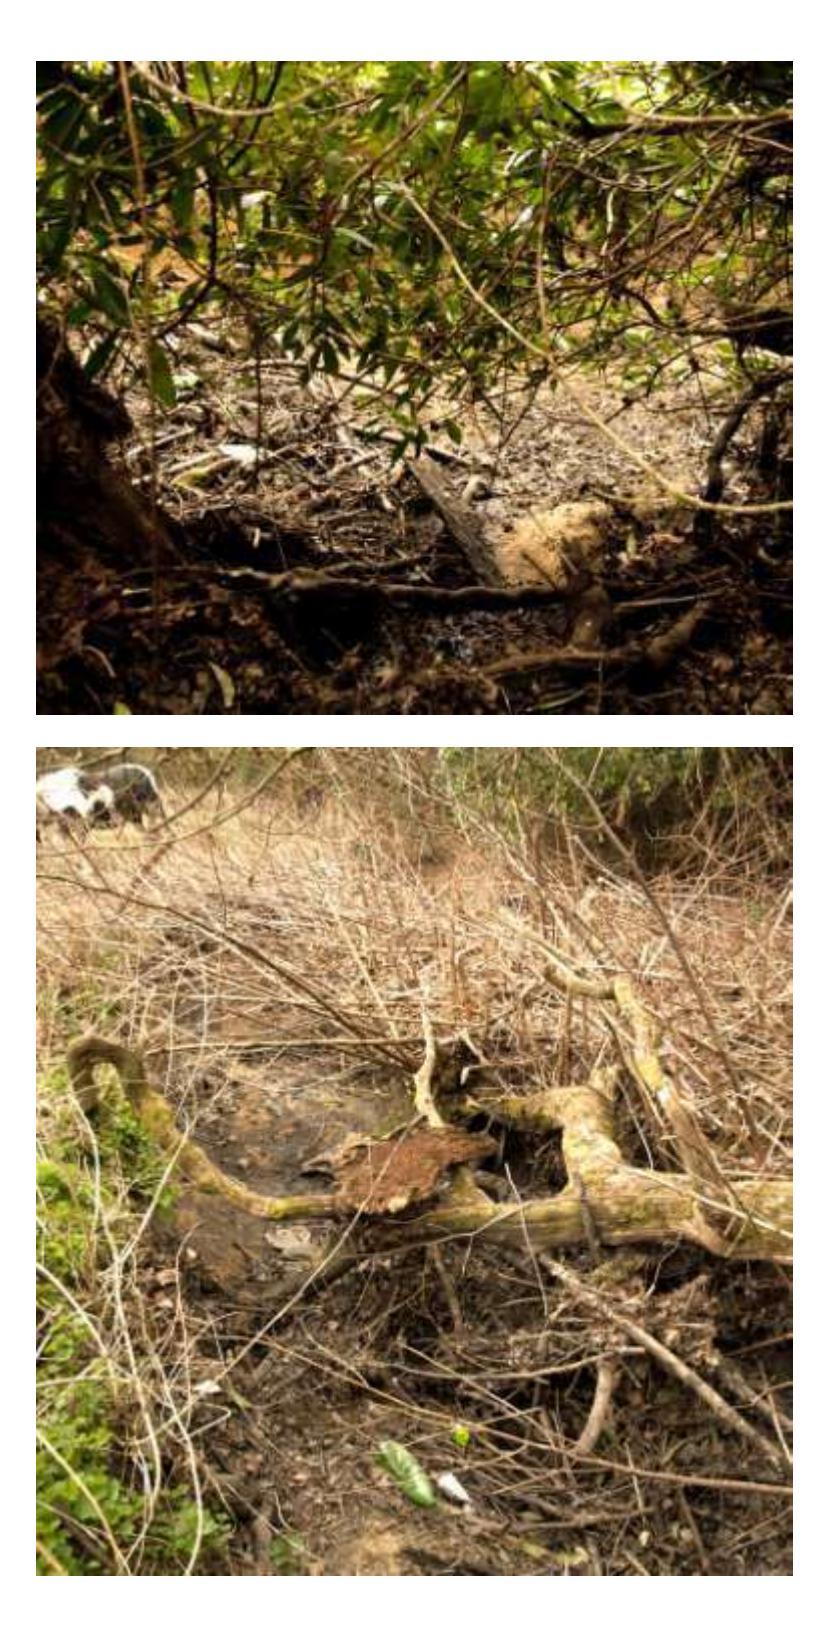
**Figure 41**. Another view of the blockage showing the overhang of rhododendron.

Figure 42. This picture shows three serious problems. The large fallen tree, the consequential accumulation of brash and artefacts, and a very extensive patch of Japanese knotweed.(the brown dead sticks are last year's growth of the knotweed). The knotweed does not affect water quality, but it is a serious invasive species and should be eradicated. Its presence will seriously limit the use of Compton field for either housing or green infrastructure.

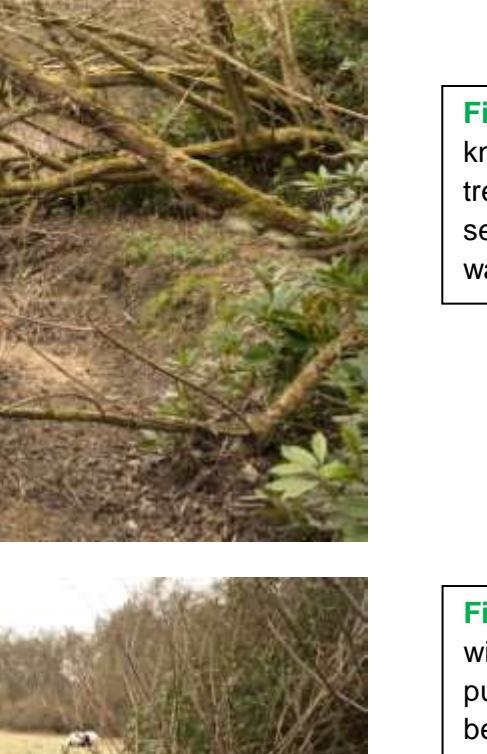
**Figure 43**. Alongside the knotweed patch is another fallen tree that is beginning to cause a serious blockage to the flow of water.

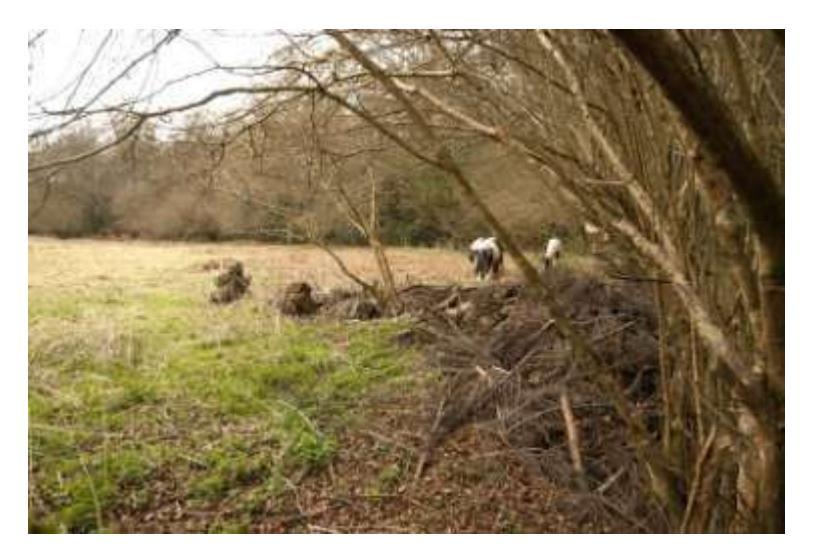
**Figure 45**. Just downstream from the knotweed patch is a large pile of dry cuttings. Probably the best way of disposing of this debris is by burning it on the knotweed

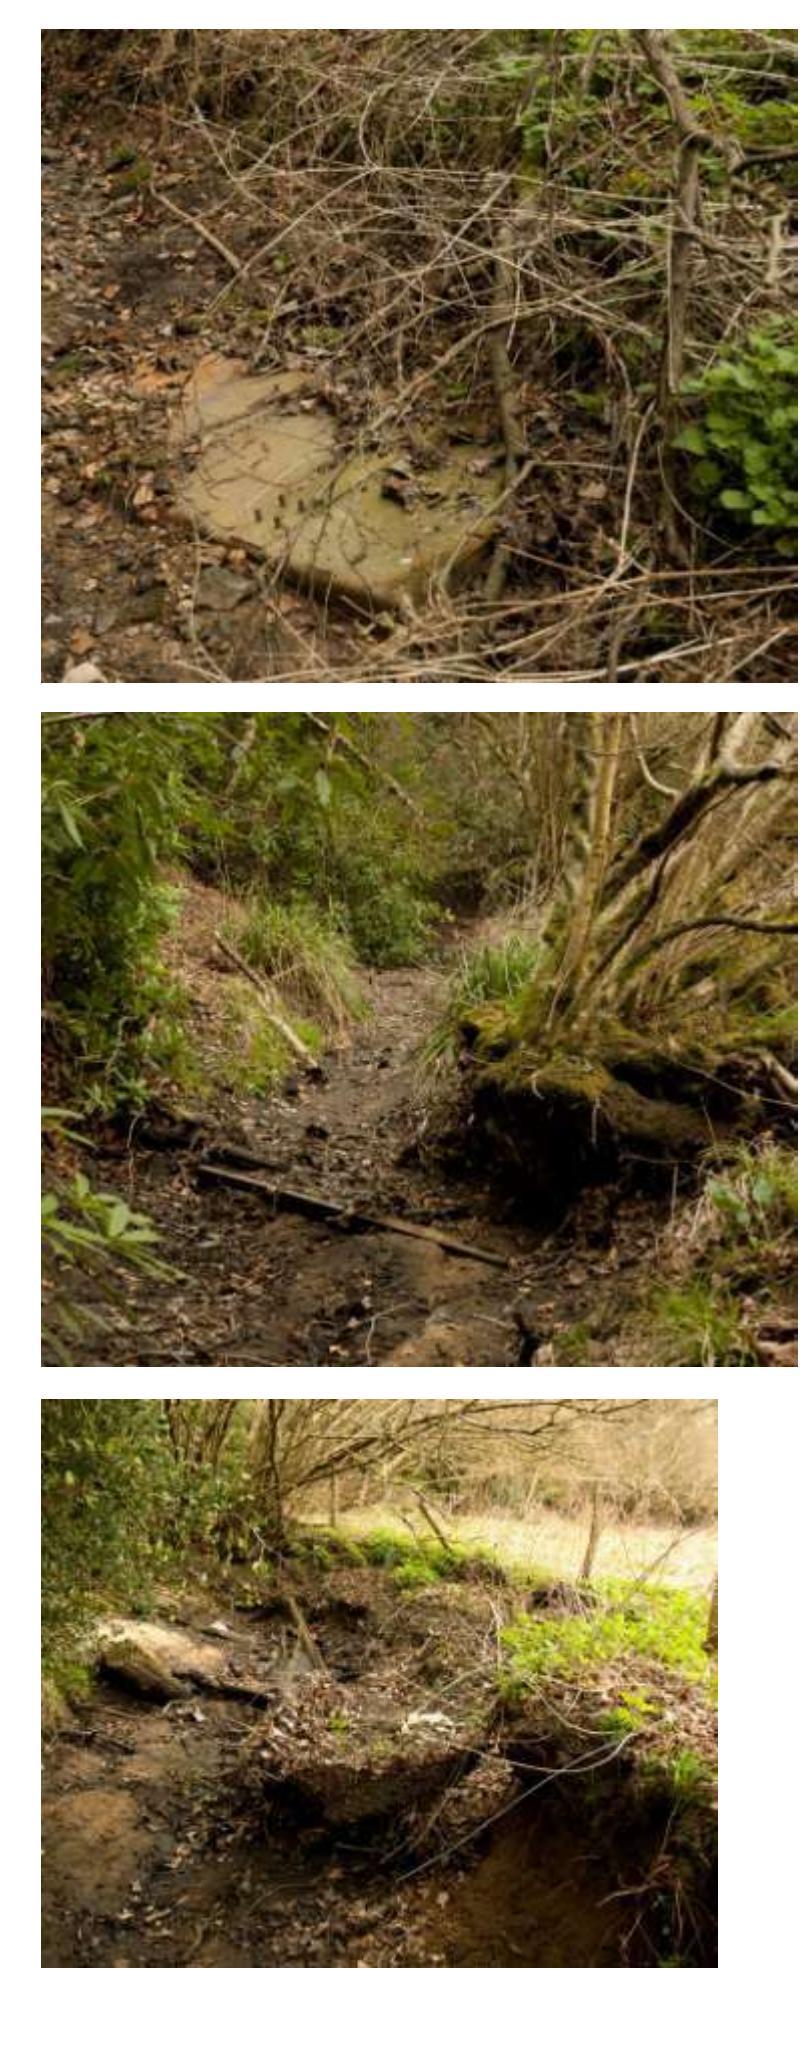
**Figure 46**. Buried in the stream bed is a large galvanised water tank, which need to be dug out and removed.

**Figure 47**. Just downstream from the tank a fence post lies in the stream bed under a severely eroded hazel coppice.

**Figure 48**. The fence here has fallen into the stream, and the netting has trapped a large accumulation of leaves and artefacts. While volunteers can clear the accumulated debris, the fence will need to be repaired by the land-owner.

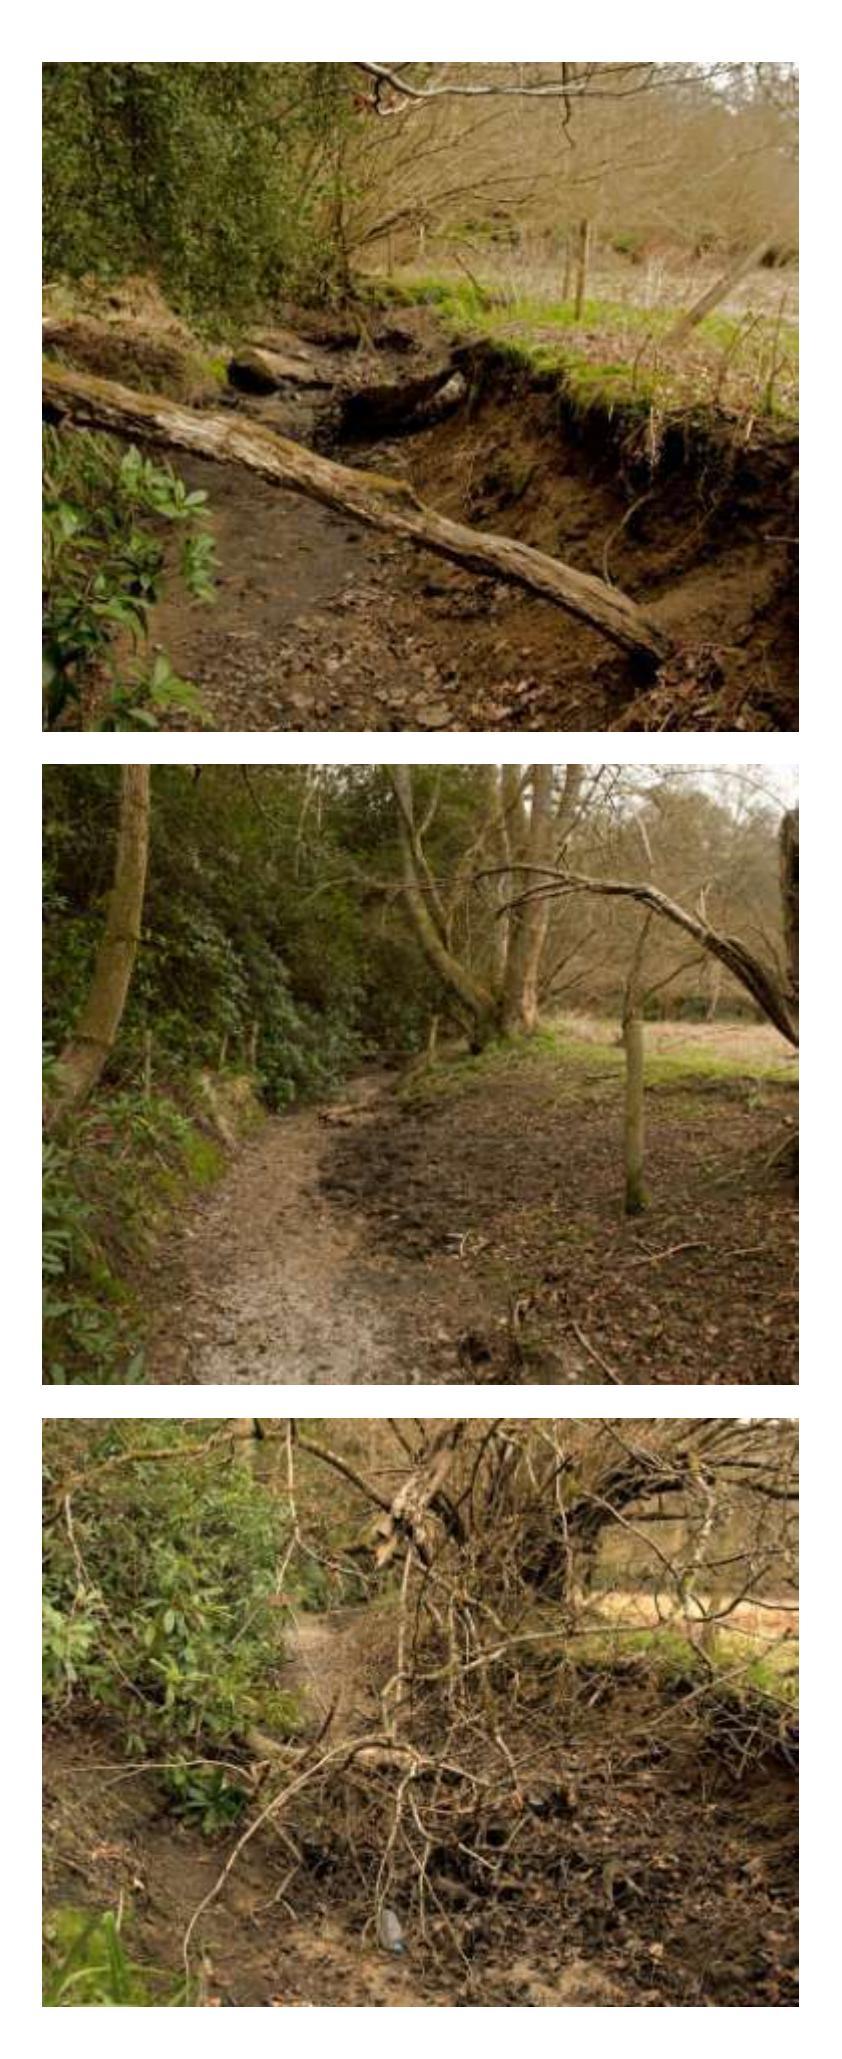
**Figure 49**. These logs cluttering the stream bed are probably just within the capabilities of volunteers to remove.

**Figure 50**. The fence has been diverted to cross the stream. While this gives the grazing horses access to the water in the stream it also introduced manure and mud into the flow, as is evident from the trampling.

**Figure 51**. Another accumulation of bash trapping artefacts in the stream bed.

Figure 52. Bank erosion has cause this hazel coppice to fall and partially block the stream bed.

Figure 53. A tree across the stream will need a chain saw to clear. The overhanging rhododendron can be cut back and the artefacts littering the stream bed removed by volunteers.

**Figure 54**. The boundary fence which has fallen into the stream bed is accumulating all manner of debris. While the debris can be cleared by volunteers, repairing the fence is a matter for the owners. Note the pumping station can be seen in the background.

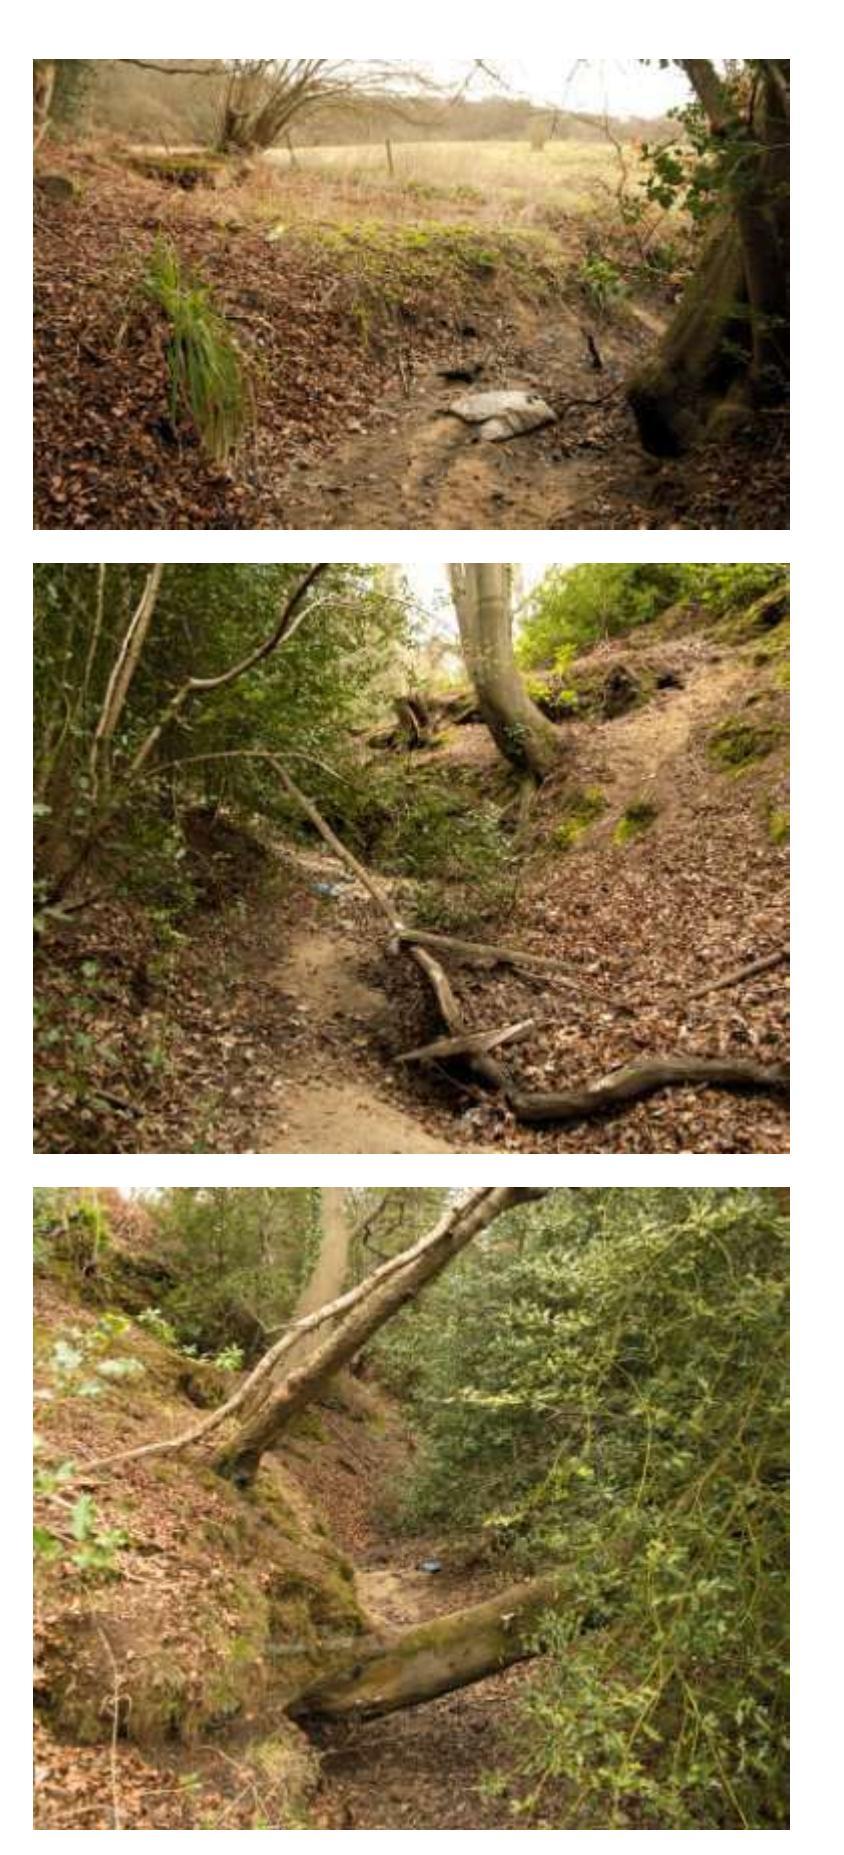
**Figure 55**. Just downstream of the collapsed fence a plastic sack, a length of hose and accumulated bash litter the stream bed.

Figure 56. A fence post and some artefacts litter the stream bed

**Figure 57**. Two large trees leaning over the steep banks in this sector, need to be cleared, as do the overhanging holly and rhododendron along with the artefacts.
