# A Preliminary Survey of the status of the Bourne Stream

Prepared for the meeting on the Farnham group for Wey Valley Catchment Programme 22<sup>th</sup> August 2012

Martin Angel and Noel Moss The Bourne Conservation Group

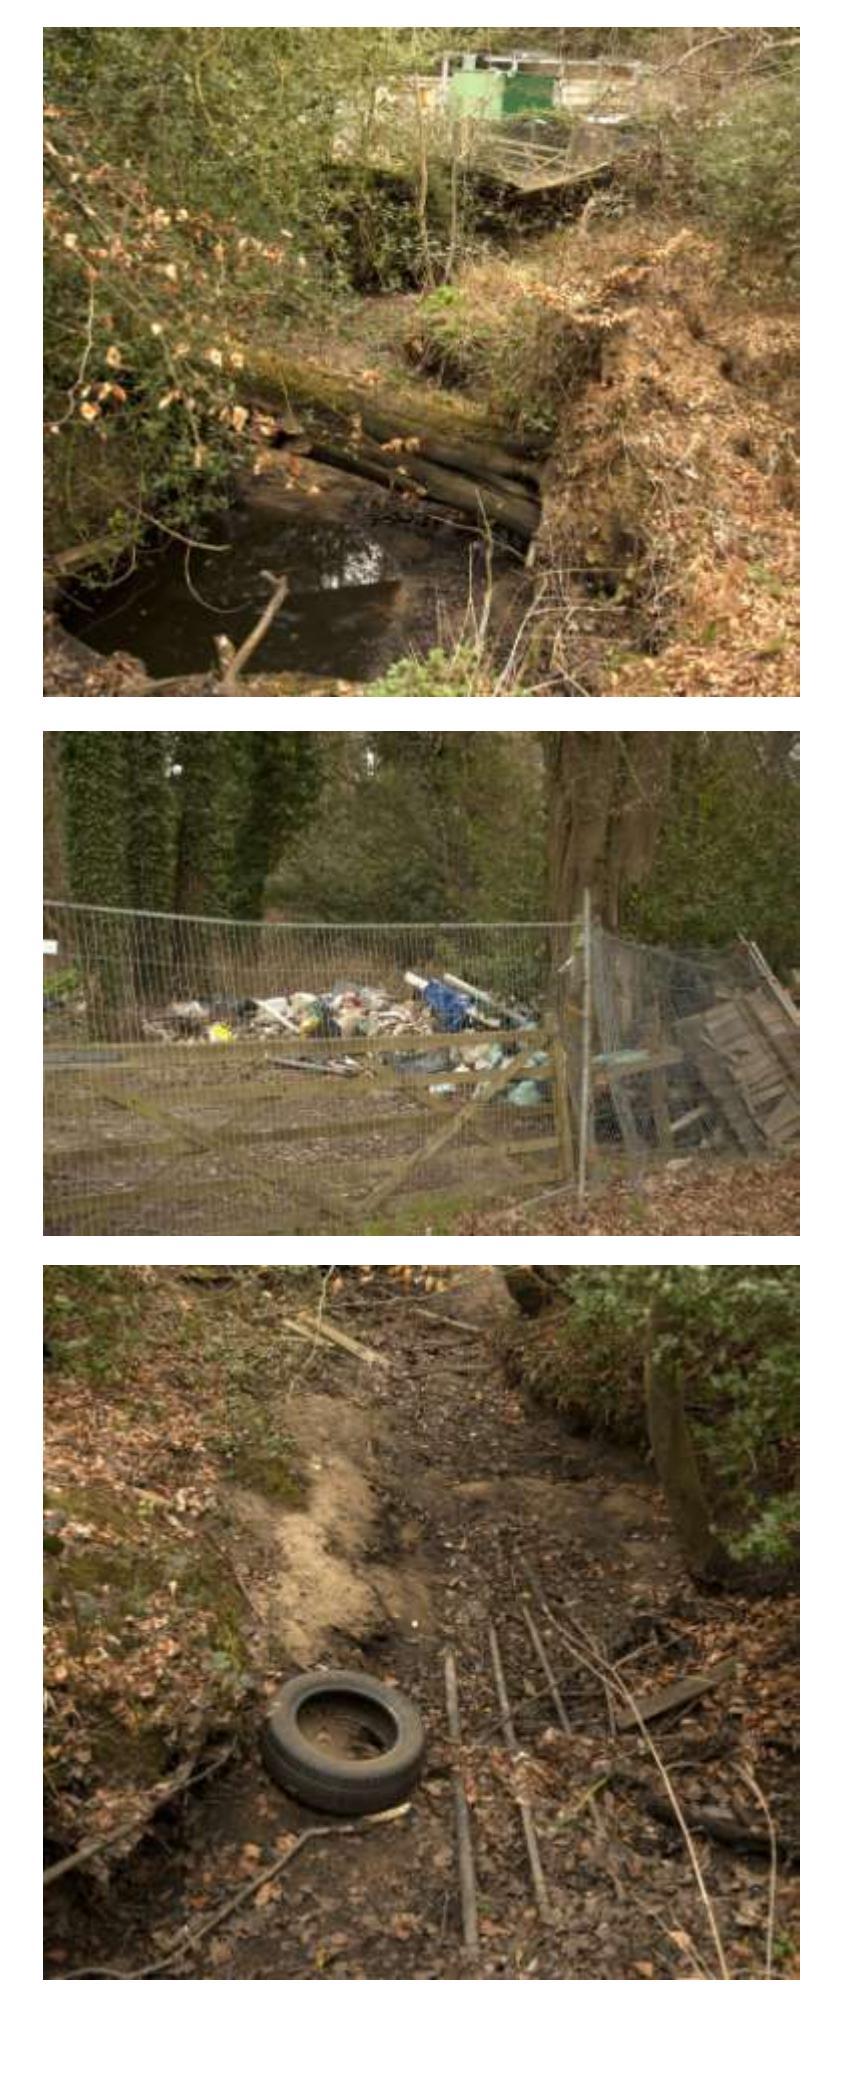
**Figure 58**. Just upstream from the pumping station a large tree has fallen across the water course and beneath it is a pool of water. Note that the fence inside the gate has fallen down.

**Figure 59**. By the gate into Compton Field near the pumping station is a serious amount of flytipping. The rubbish has begun t fall into the stream because the fence has collapsed, and will be a serious source of pollution reaching the main river unless it is cleared.

**Figure 60**. This shows some serious rubbish – a tyre, old gate and a variety of other artefacts that have fallen into the stream bed.

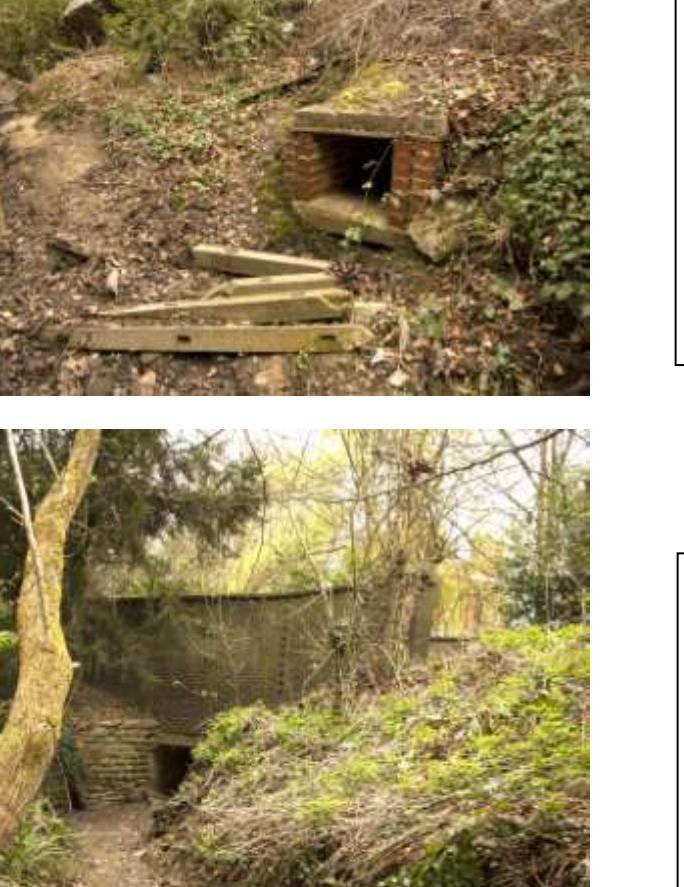
Figure 61. The emergency overflow for the pumping station. Note its sad state of repair and the concrete posts. Behind rubbish from the fly-tipping is falling into the stream. Noisome effluents have been known to be emitted from this overflow. In the past. If we achieve nothing else the cleaning up of this area must be a priority.
