# A Preliminary Survey of the status of the Bourne Stream

Prepared for the meeting on the Farnham group for Wey Valley Catchment Programme 22<sup>th</sup> August 2012

Martin Angel and Noel Moss The Bourne Conservation Group

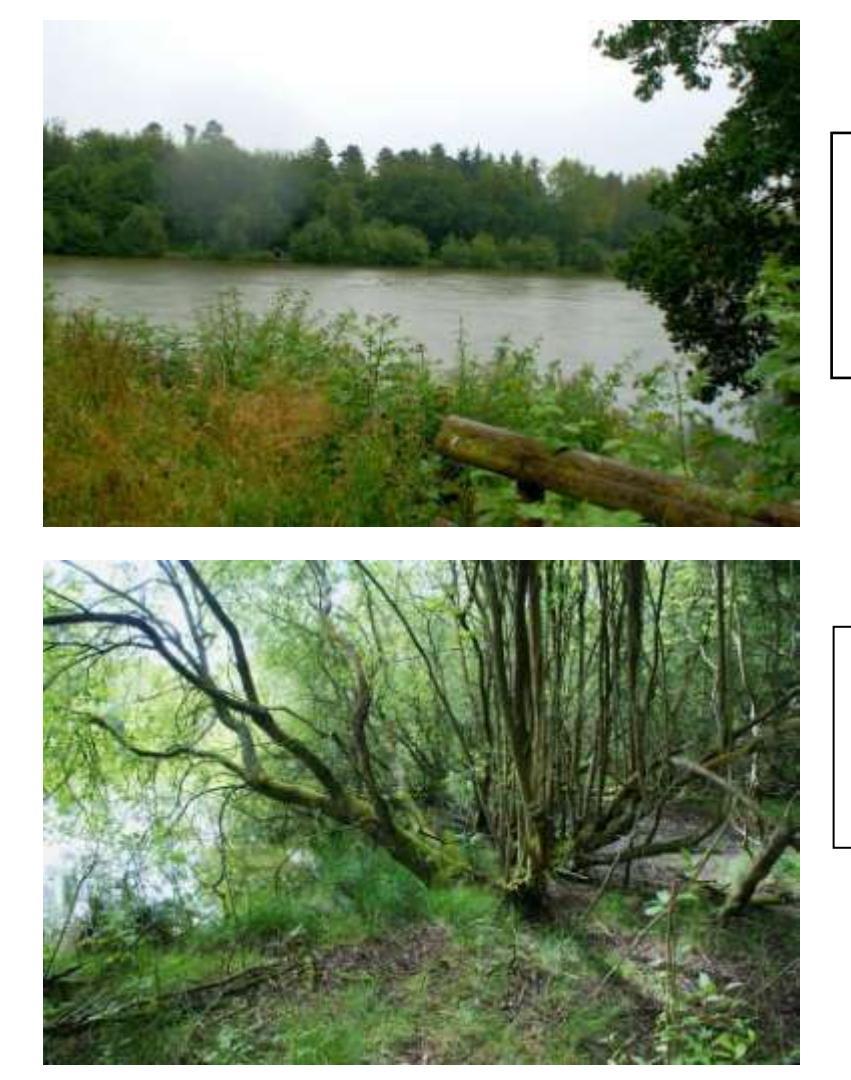
**Figure 3**. There are two main sources in Alice Holt Forest. This is the main one that is Lodge Pond that drains into marshy ground and thence the water flows over a weir into another

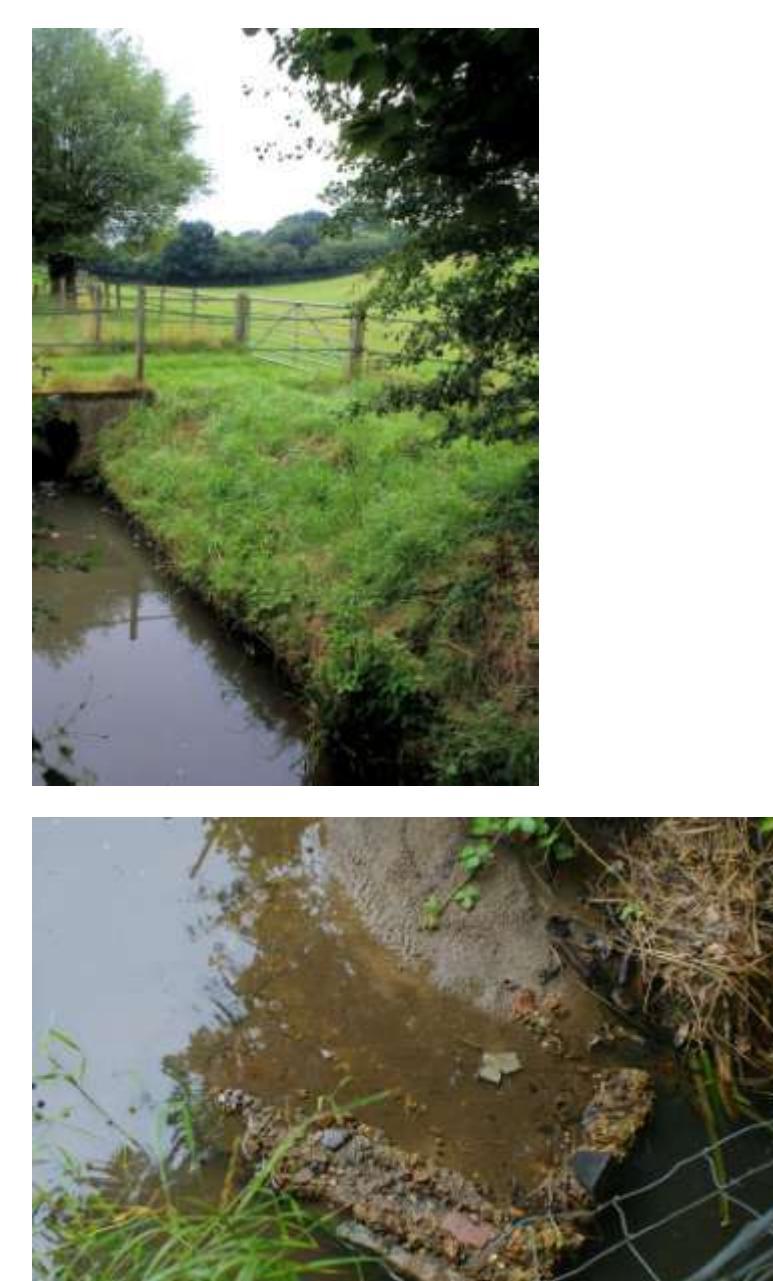
**Figure 8**. The stream flows through farmland.

**Figure 9.** A large masonry block that has come to rest under a footbridge, along with untidy wire.

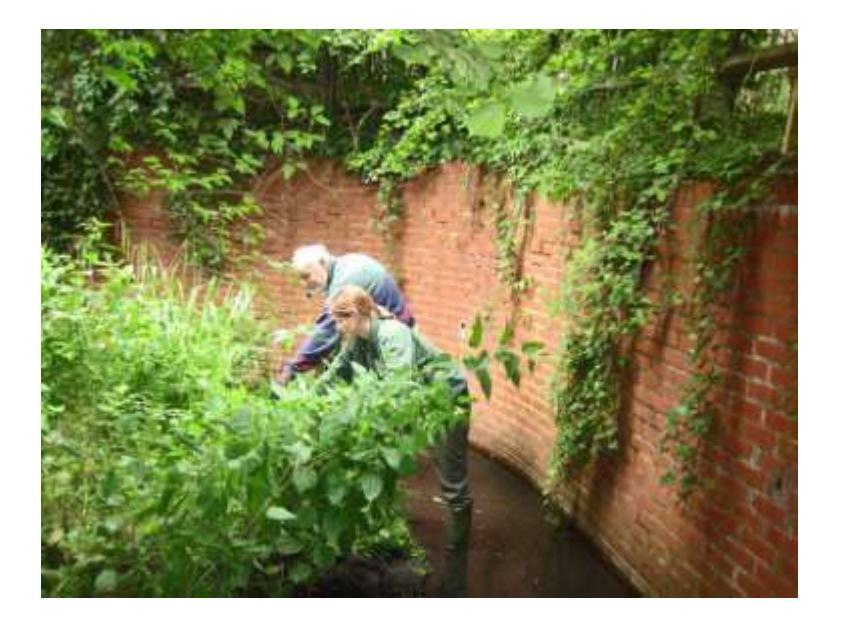
Figure 16. Formal flood defences at a choke point probably put in by Farnham Urban District Council. This has been a hot spot for Himalayan Balsam, but this invasive alien plant has been eradicated by The Bourne Conservation Group here and throughout the length of the Bourne Valley.

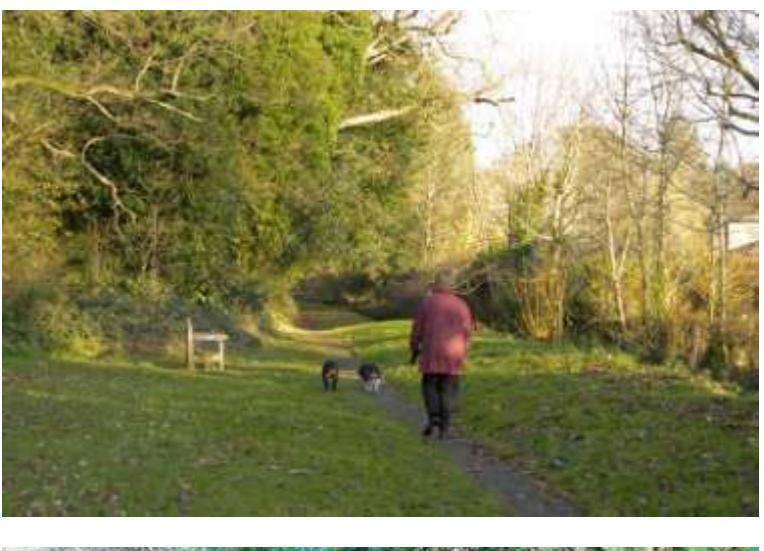
Figure 17. Sturt Walk – 'Footpath 215' the stream is to the right. This is one of the many public footpaths on land belonging to Waverley Borough Council that criss-cross The Bourne. The WBC is assiduous in mowing the grass under contract, but attempts are being made to change the mowing regime to encourage wild flowers. These footpaths are well used by local people.

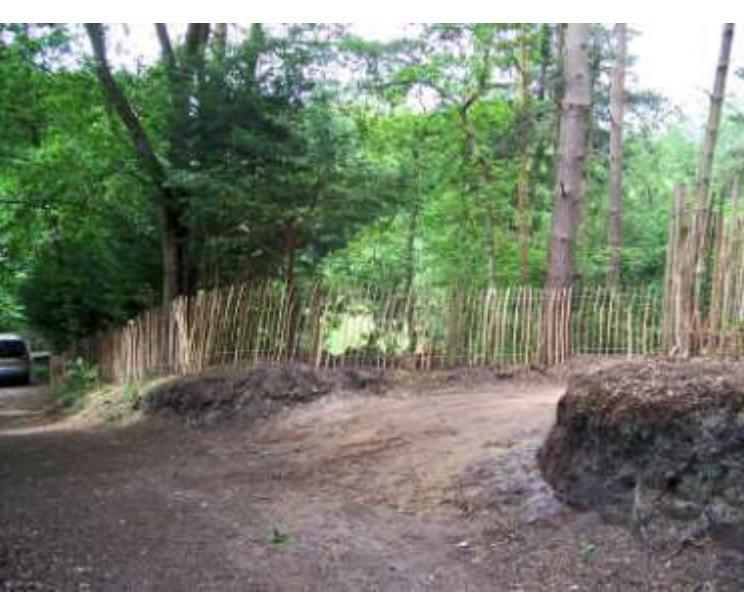
Figure 23. Alongside Bourne Grove, public highway, the stream's embankments tend to be unstable. This stretch is currently the subject of a dispute over ownership of the bank.

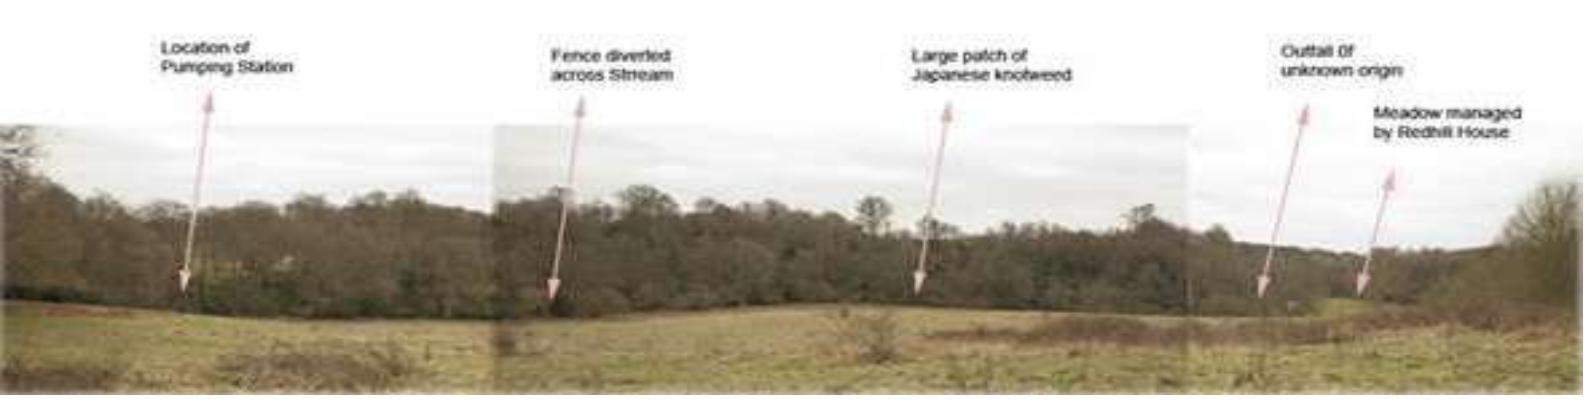
**Figure 24** Panoramic view of Compton Field where the stream flows along the edge of the woodland.

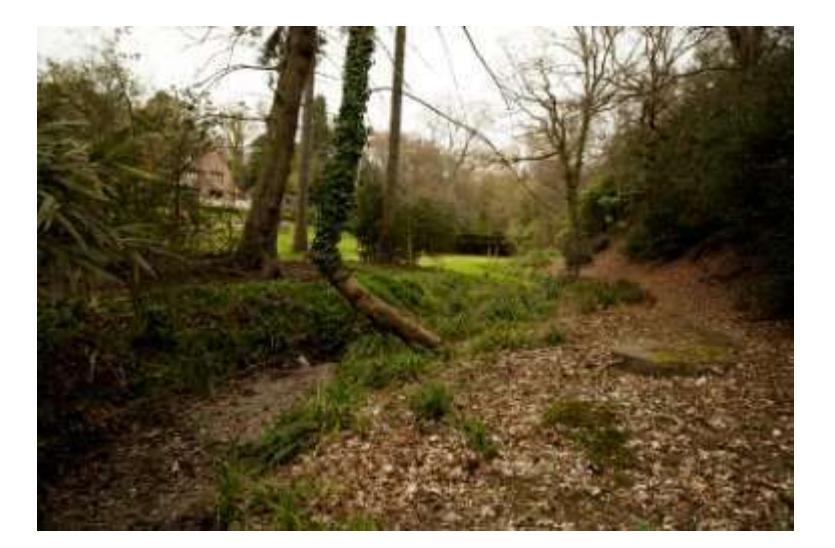
Figure 28. Where the stream flow through the garden of Redhill House it is reasonably clear of obstructions and debris. We do not know what lies under the circular concrete lid.

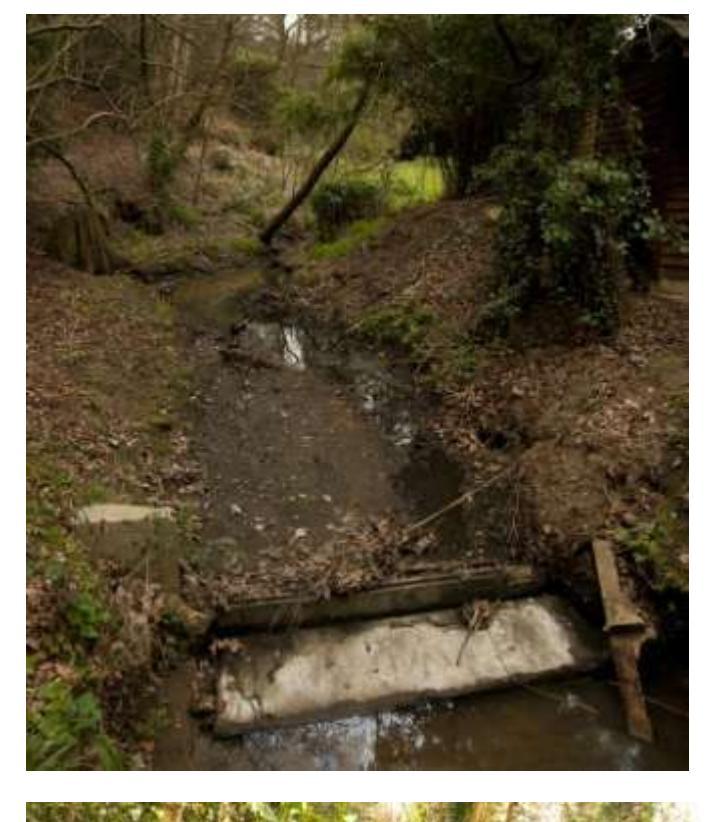
Figure 29. View upstream towards the garden of Redhill House showing a small weir that had kept water in the stream even during this drought period. A week later after heavy rain this weir would have been under water.

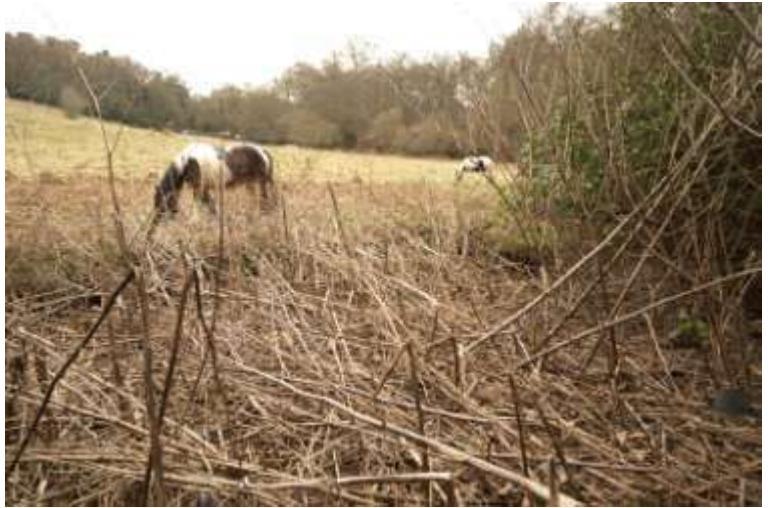
Figure 44. The knotweed patch with Compton Field behind. The pumping station is directly beyond the hose in the foreground. Two years ago this area supported rampant growth of Himalayan Balsam, but this invasive alien has been almost totally eliminated from the Bourne Valley by the Bourne Conservation Group.
